FACILITY STATUS CHANGE FORM

| Date Submitted: | Area: | Control #: | | |
|--|---|---|--|--|
| Chris Strand | 328, 328A, and 328BA | | | |

Controì #: D4-300-015-1

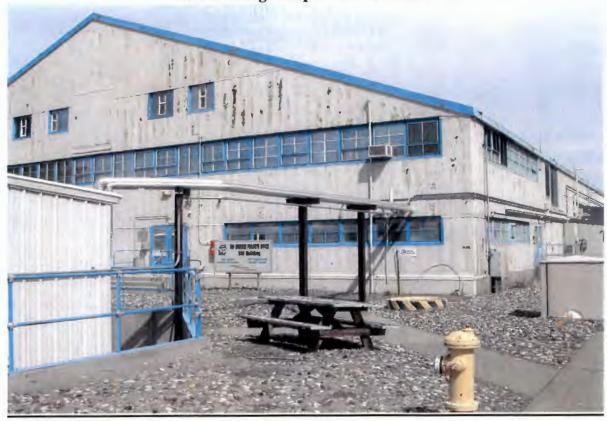
328 Building Complex before Demolition
